# Surface Development of Trailing Arms During Fully Automatic Production: Challenge and Innovation

**Senior Process Engineer  
VDL Weweler BV  
Apeldoorn**

**4TU Joint Workshop: Surfaces, Interfaces & Coatings**

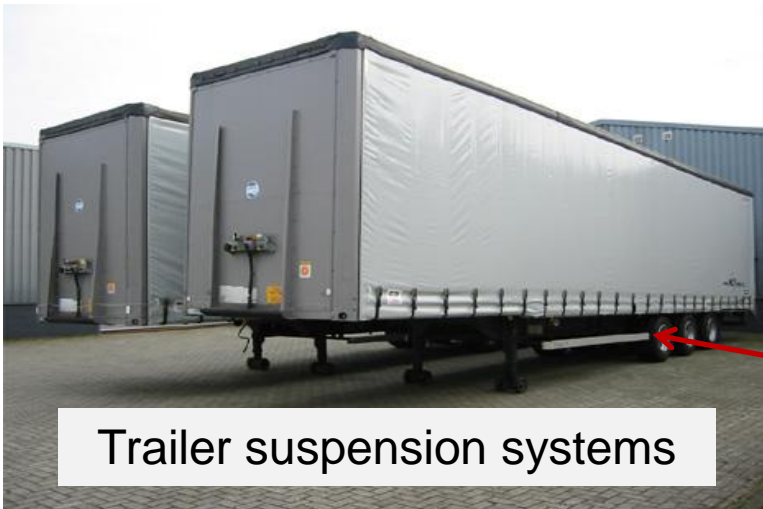
Trailer suspension systems

VDL Weweler BV develops, produces and sells various air suspension systems (>100 types) in Europe (~40% market share) and in the world (~ 20% market share) for trailers, trucks and buses.

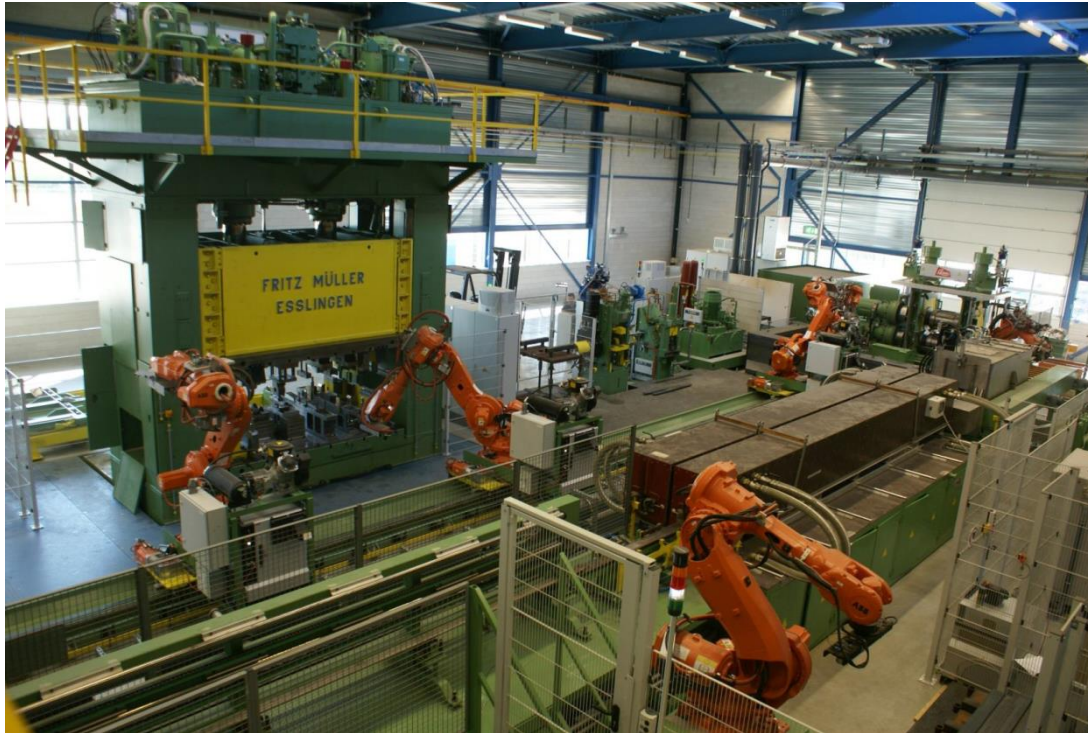
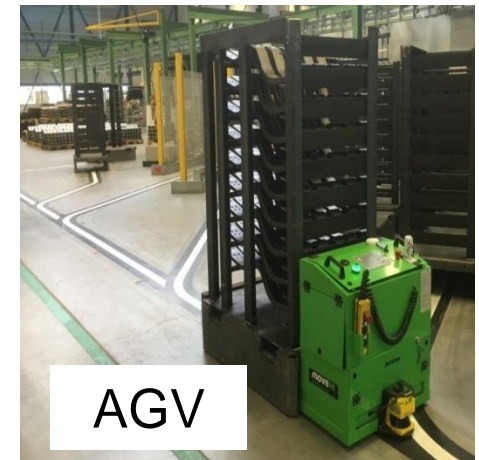
Industry 4.0 –  
smart industry

- Production time per trailing arm reduced from 5 days to 5 hours
- Robot is part of process; improved grippers
- Internal transport via AGV in forklift-free zone

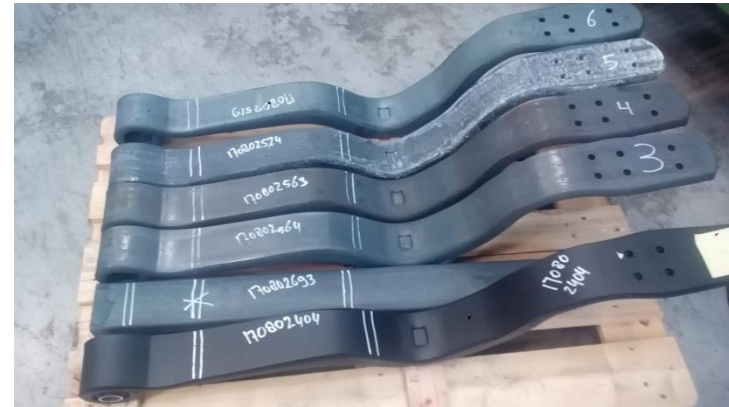
important surface factors	
outer surface	Smoothness
	Discontinuities
	Corner transition
	Cracks or/and scratch
	Shot peening coverage
	Paint layer
	Oxide and rust
	...
inner (sub) surface (< 1 mm)	Decarburized layer
	Internal oxide
	Underneath oxide
	Stress field
	(Micro) cracks
	...

Well controlled surface is not only essential for the quality of product, but also important for production.

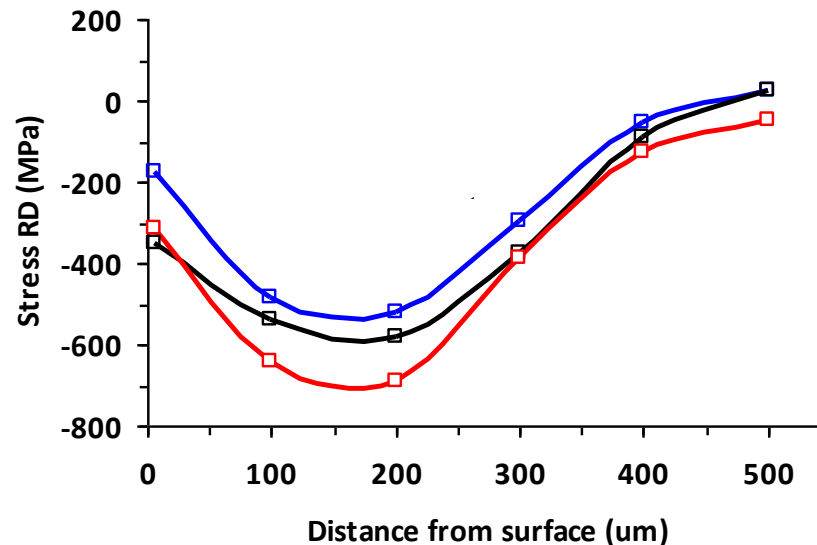
# Shot-peening to improve the fatigue lifetime

- Shot peening almost doubles the fatigue lifetimes of our products, as a compensation of the loss of decarburization
- Compressive residual stress field (CRSF) is created in a surface layer of 0,5 mm with a maximum stress at about 0,2 mm
- CRSF would be released after fatigue fracture or after reheating above 400 °C/1 hour
